NPDES  
INSPECTION REPORT

WASTEWATER TREATMENT FACILITY  
PIERCE, IDAHO

October 20, 2011

Prepared by:  
Jerry W. Shaffer  
Lewiston Regional Office  
Idaho Department of Environmental Quality

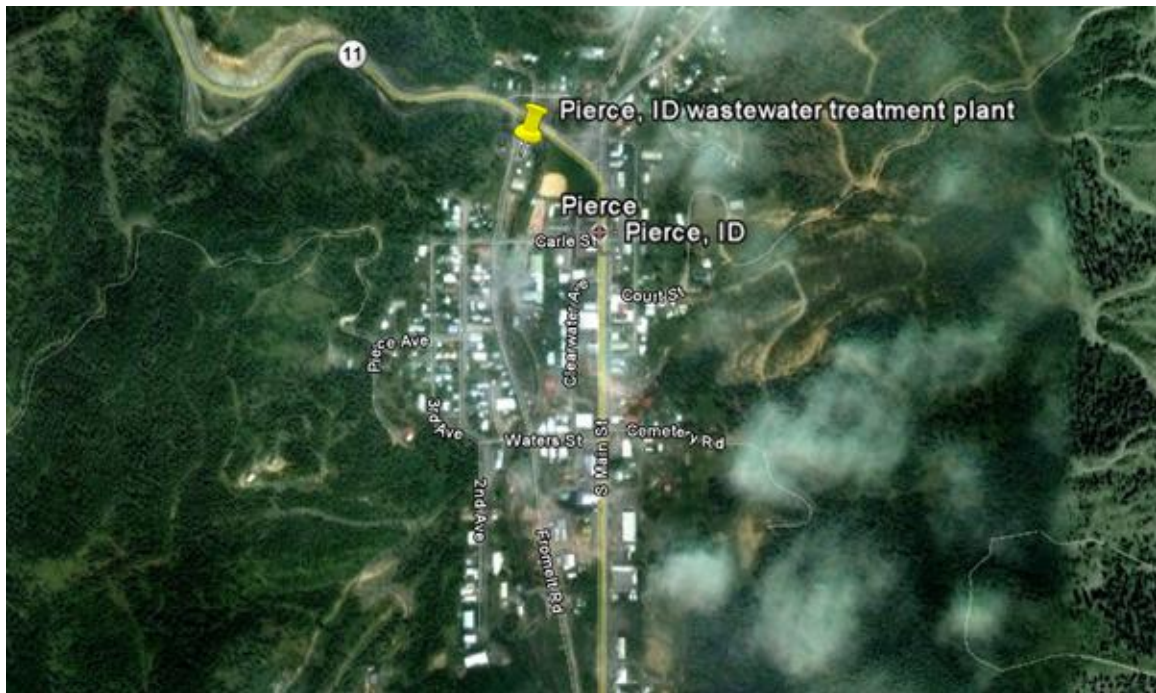
Aerial photograph of the wastewater treatment plant in Pierce, Idaho.

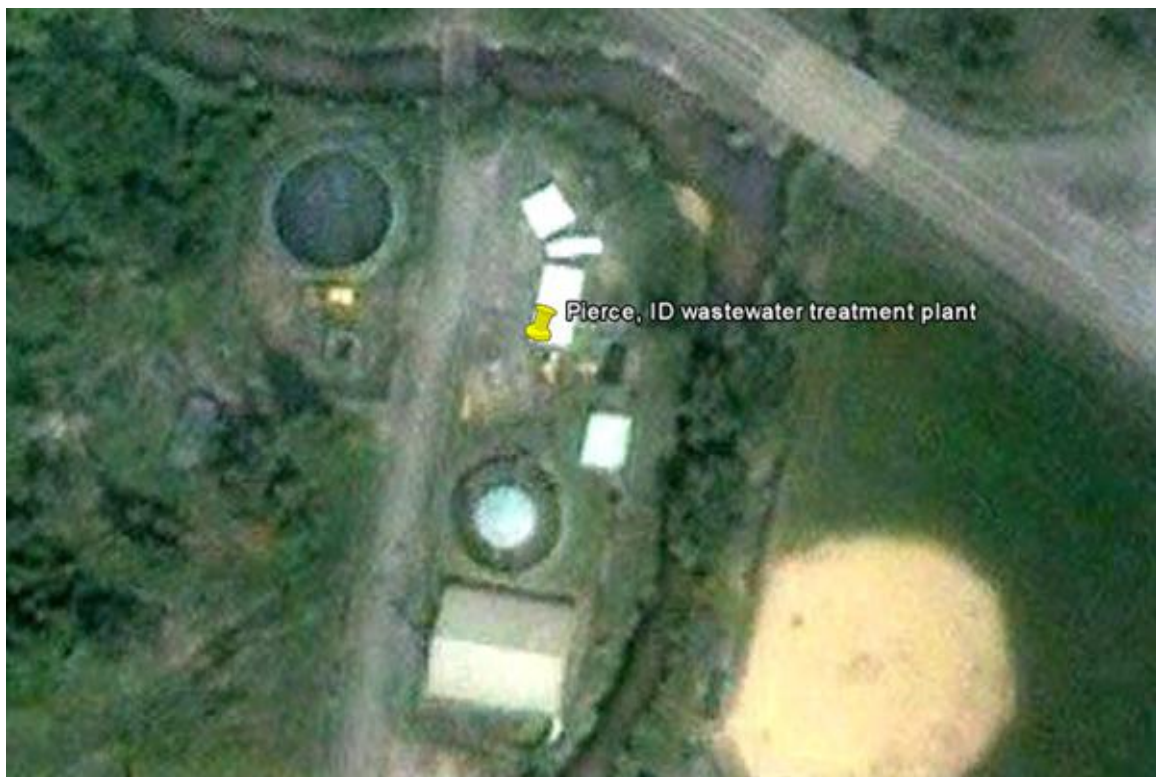
Aerial photograph of the wastewater treatment plant in Pierce, Idaho.

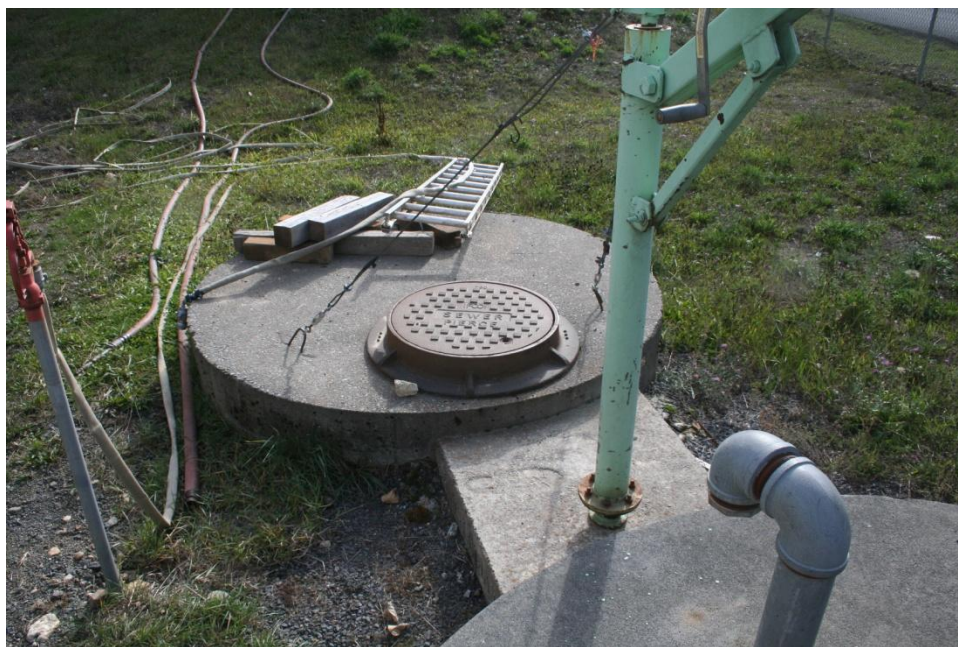
City of Pierce wastewater treatment plant sewer lift station at the head of the plant. Photo by Jerry W. Shaffer (DEQ) on October 20, 2011.

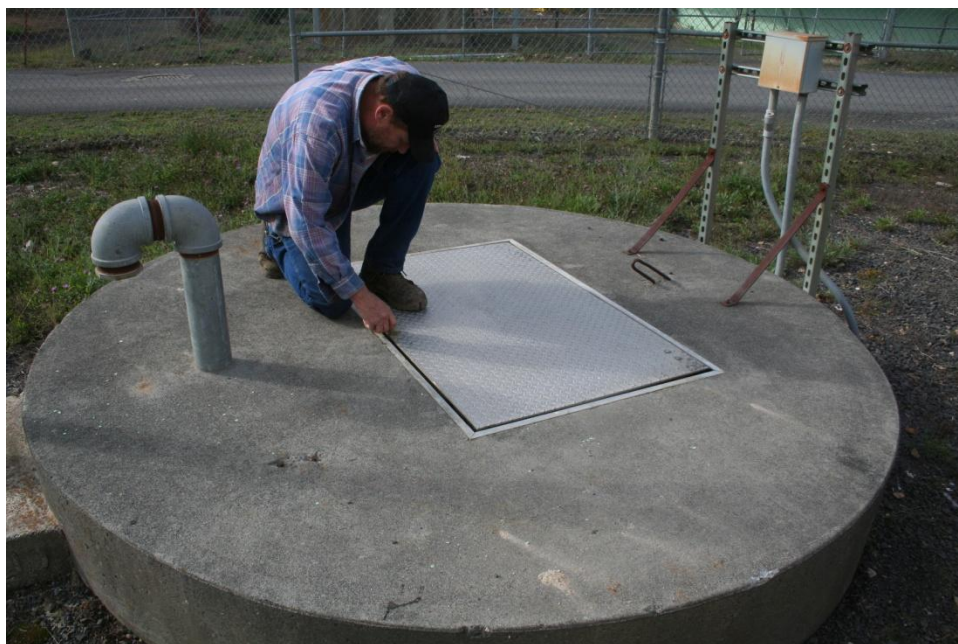
City of Pierce wastewater treatment plant sewer lift station at the head of the plant. Photo by Jerry W. Shaffer (DEQ) on October 20, 2011.

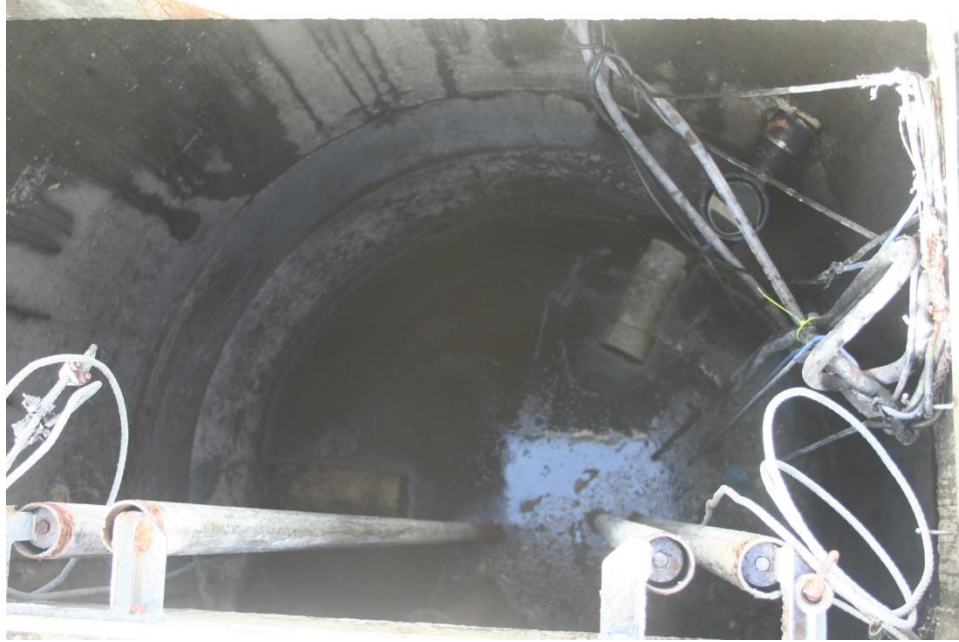
Interior of the City Pierce wastewater treatment plant sewer lift station at the head of the plant. Photo by Jerry W. Shaffer (DEQ) on October 20, 2011.

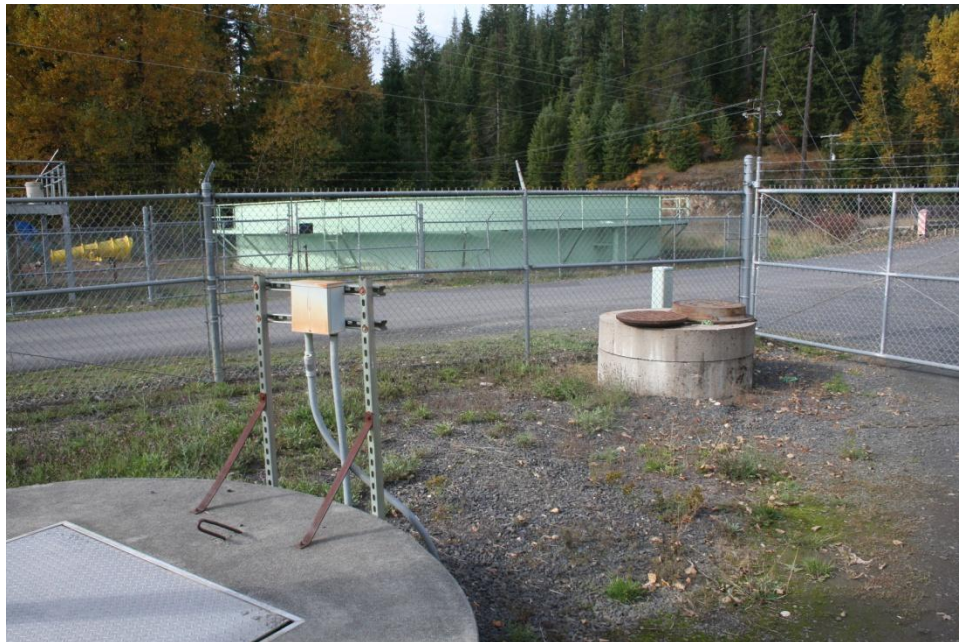
City of Pierce wastewater treatment plant with sewer lift station in foreground, chlorine injection point in the middle, with the final sedimentation basin in the background. Photo by Jerry W. Shaffer (DEQ) on October 20, 2011.

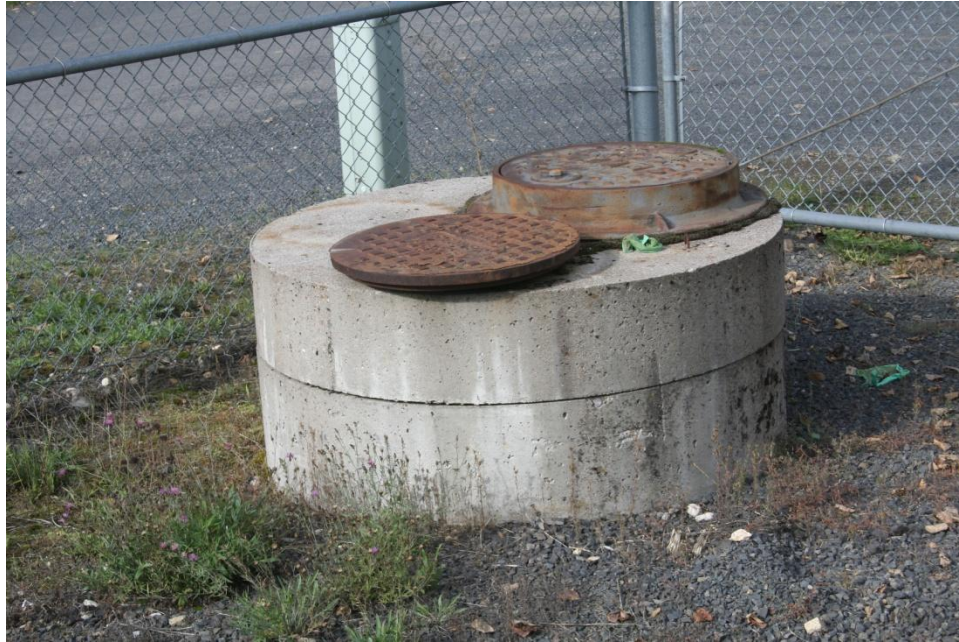
City of Pierce wastewater treatment plant chlorine injection point. Photo by Jerry W. Shaffer (DEQ) on October 20, 2011.

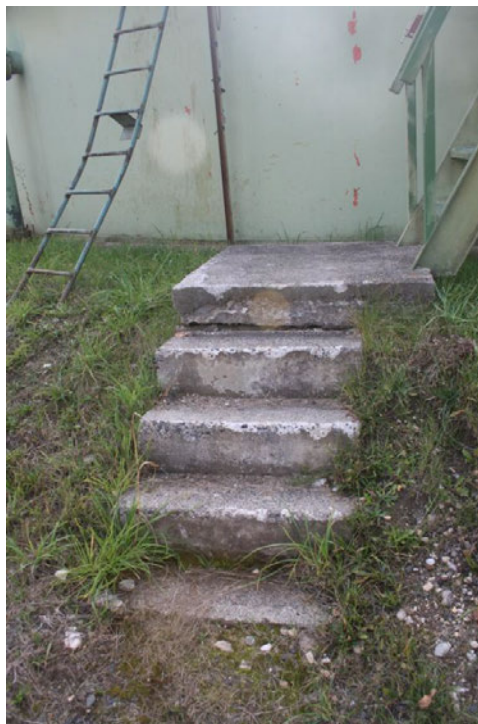
City of Pierce wastewater treatment plant access stairs to the wastewater package treatment plant. Photo by Jerry W. Shaffer (DEQ) on October 20, 2011.

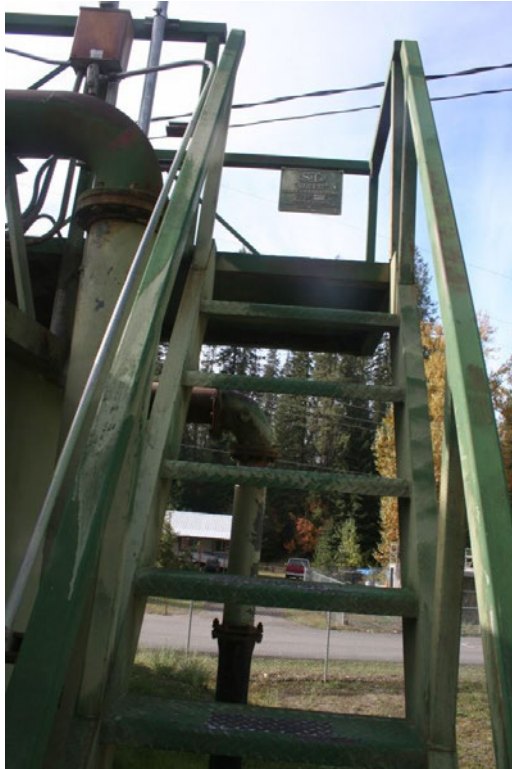
City of Pierce wastewater treatment plant access to wastewater package treatment plant. Photo by Jerry W. Shaffer (DEQ) on October 20, 2011.

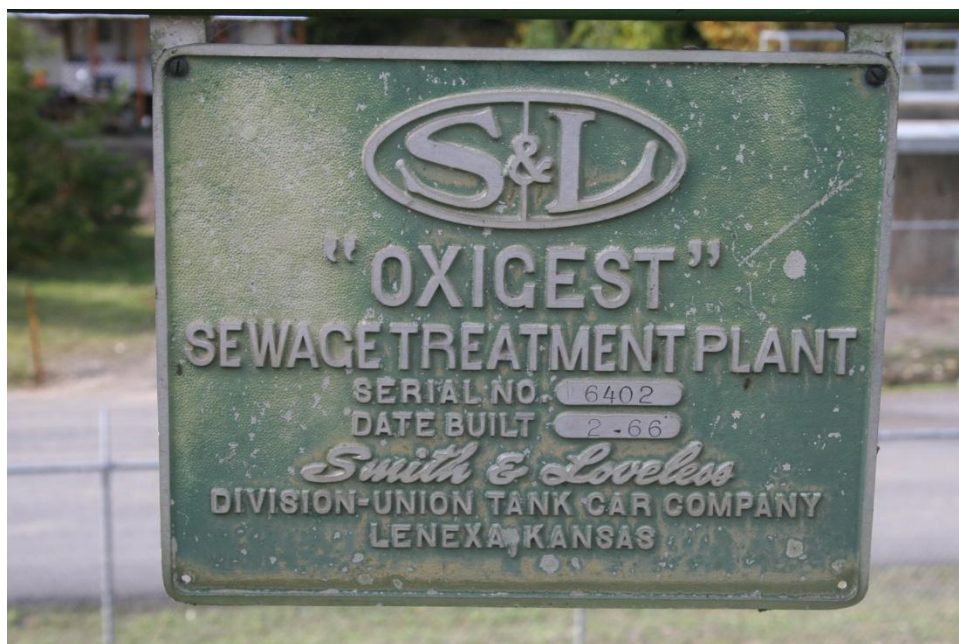
Nameplate on the City of Pierce wastewater treatment plant package treatment plant. Photo by Jerry W. Shaffer (DEQ) on October 20, 2011.

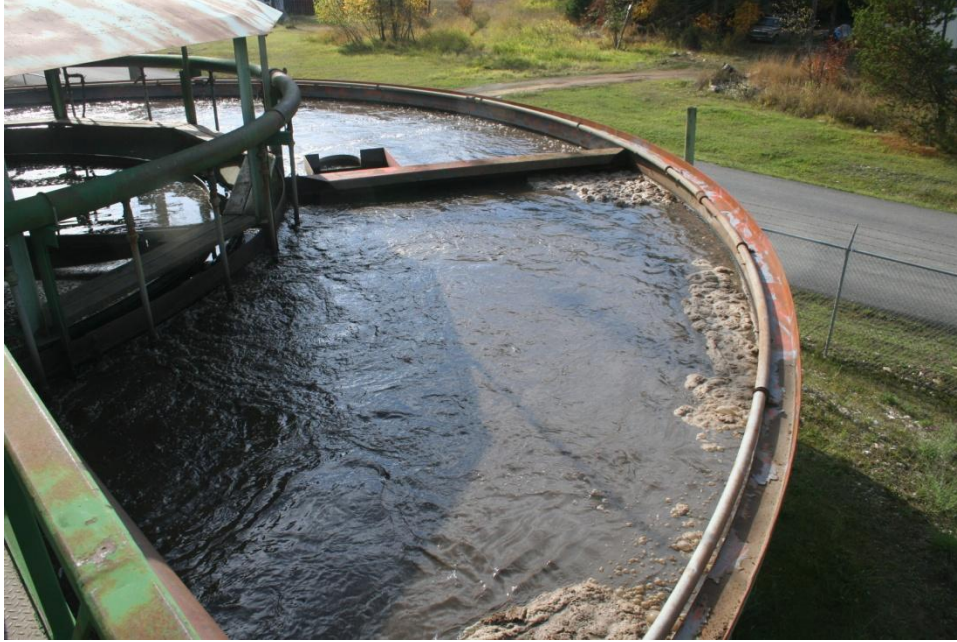
City of Pierce wastewater package treatment plant oxidation ditch. Photo by Jerry W. Shaffer (DEQ) on October 20, 2011.

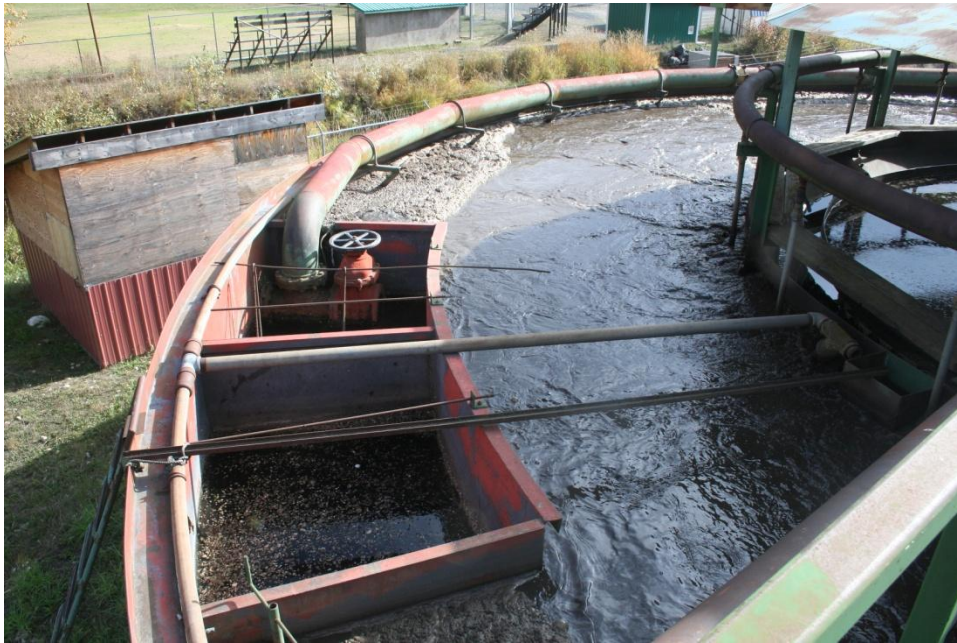
City of Pierce wastewater package treatment plant oxidation ditch. Photo by Jerry W. Shaffer (DEQ) on October 20, 2011.

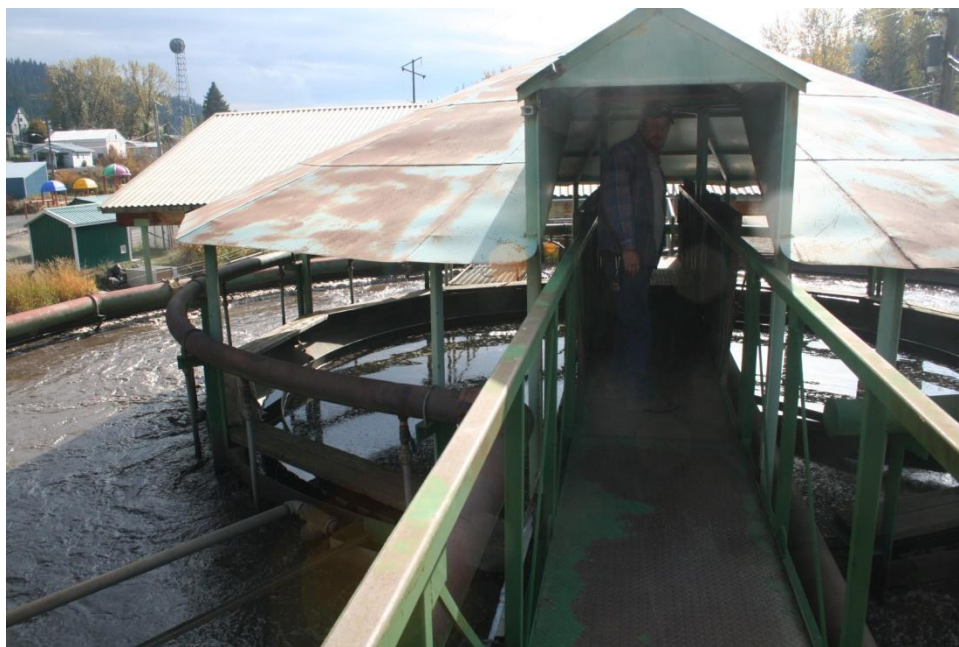
City of Pierce wastewater treatment plant oxidation ditch and clarifier (under roof). Photo by Jerry W. Shaffer (DEQ) on October 20, 2011.

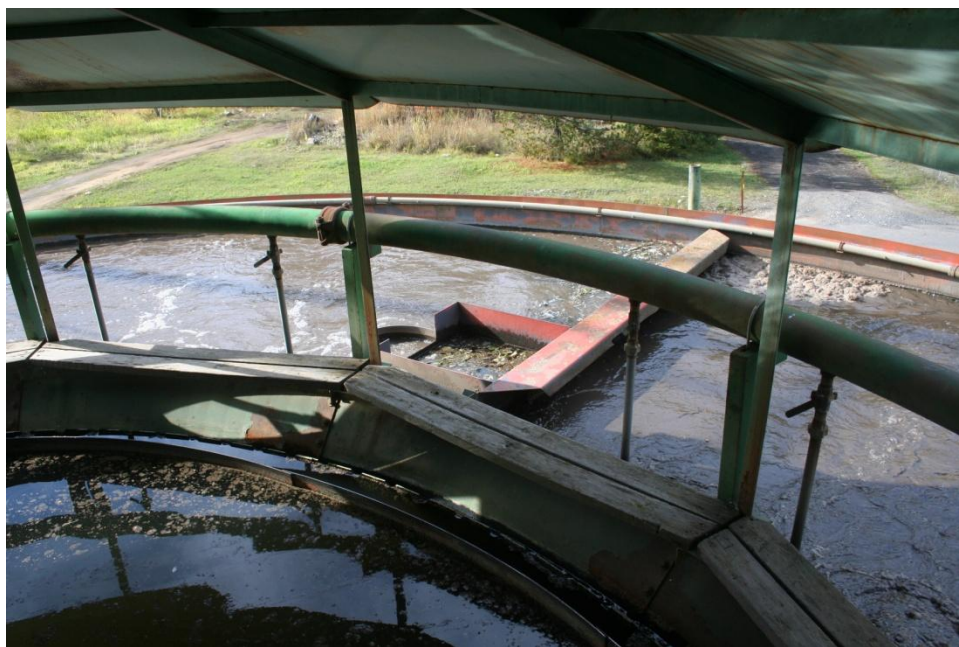
City of Pierce wastewater treatment plant oxidation ditch and clarifier. Photo by Jerry W. Shaffer (DEQ) on October 20, 2011.

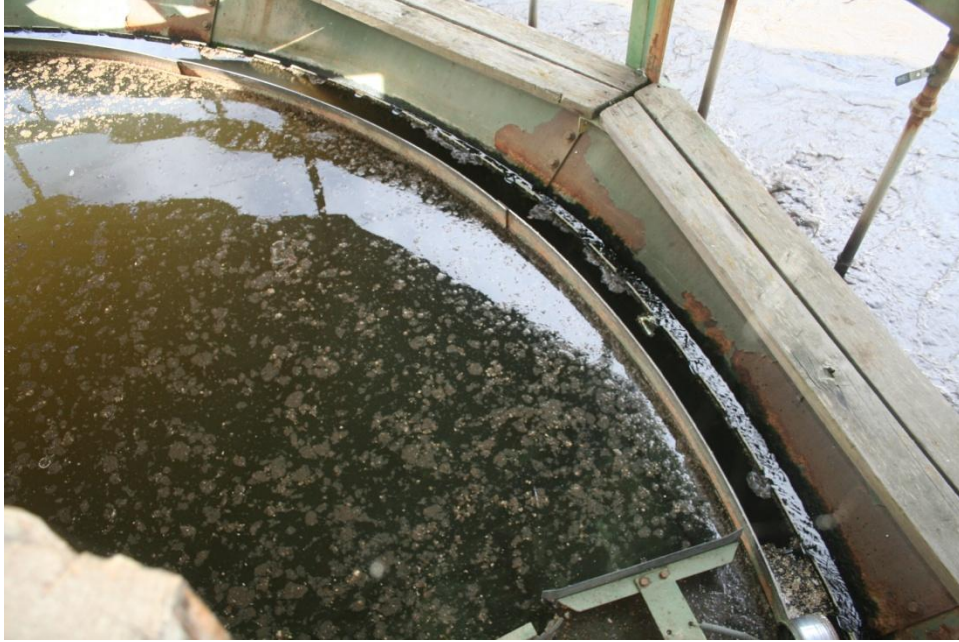
of Pierce wastewater treatment plant clarifier. Photo by Jerry W. Shaffer (DEQ) on October 20, 2011. City

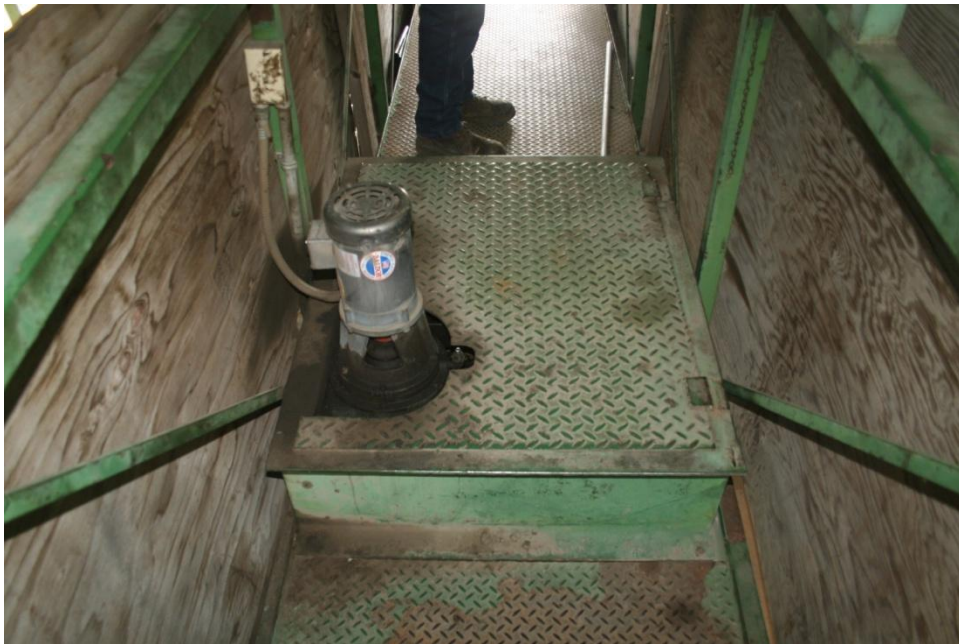
City of Pierce wastewater treatment plant clarifier motor. Photo by Jerry W. Shaffer (DEQ) on October 20, 2011.

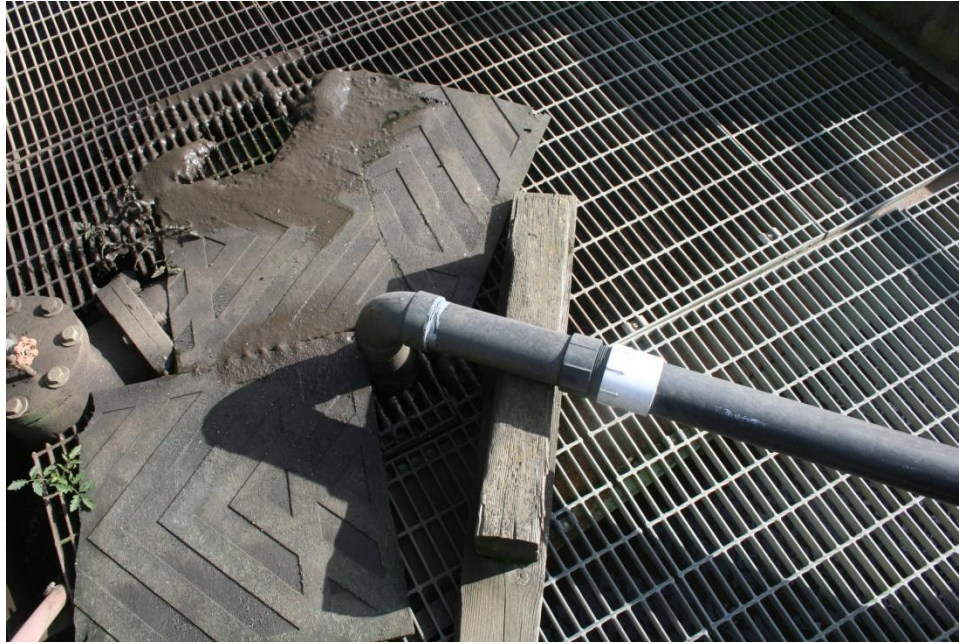
City of Pierce wastewater treatment plant return sludge pipe on wastewater package treatment plant. Photo by Jerry W. Shaffer (DEQ) on October 20, 2011.

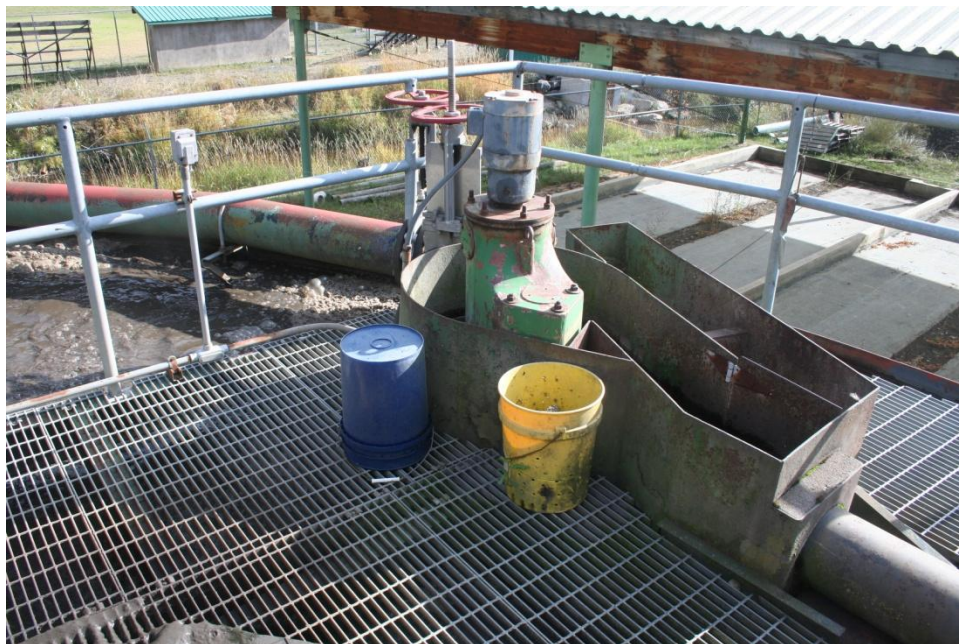
City of Pierce wastewater treatment plant influent comminutor and bar screen bypass. Photo by Jerry W. Shaffer (DEQ) on October 20, 2011.

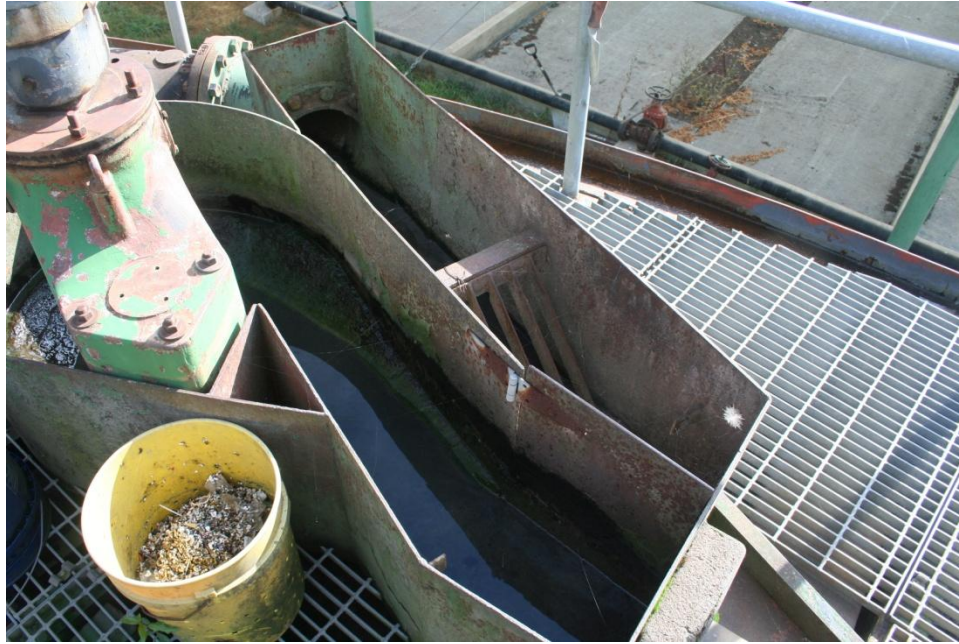
City of Pierce wastewater treatment plant influent comminutor and bar screen bypass. Photo by Jerry W. Shaffer (DEQ) on October 20, 2011.

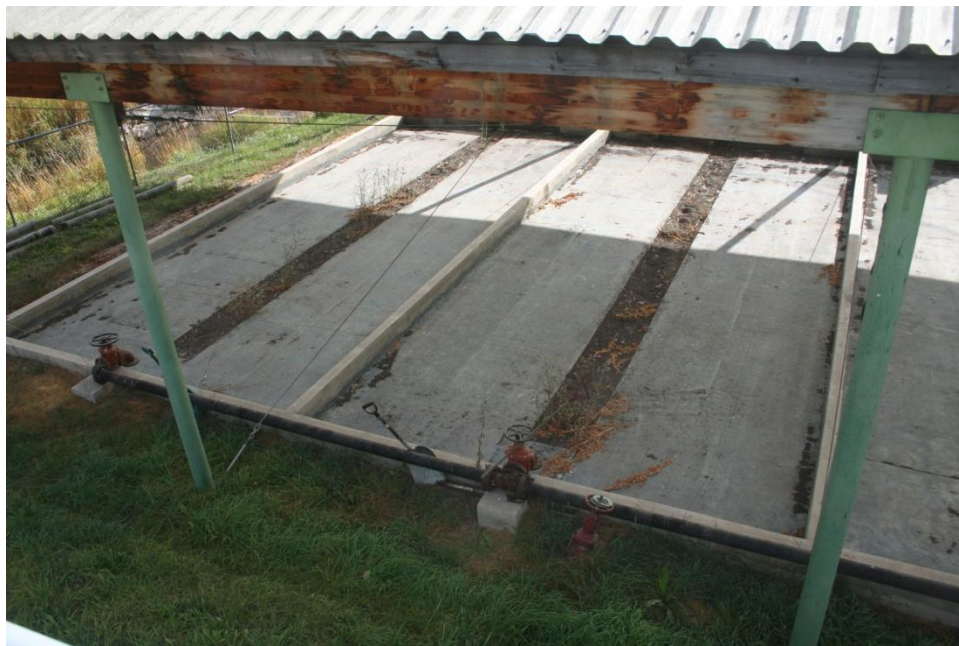
City of Pierce wastewater treatment plant sludge drying beds. Photo by Jerry W. Shaffer (DEQ) on October 20, 2011.

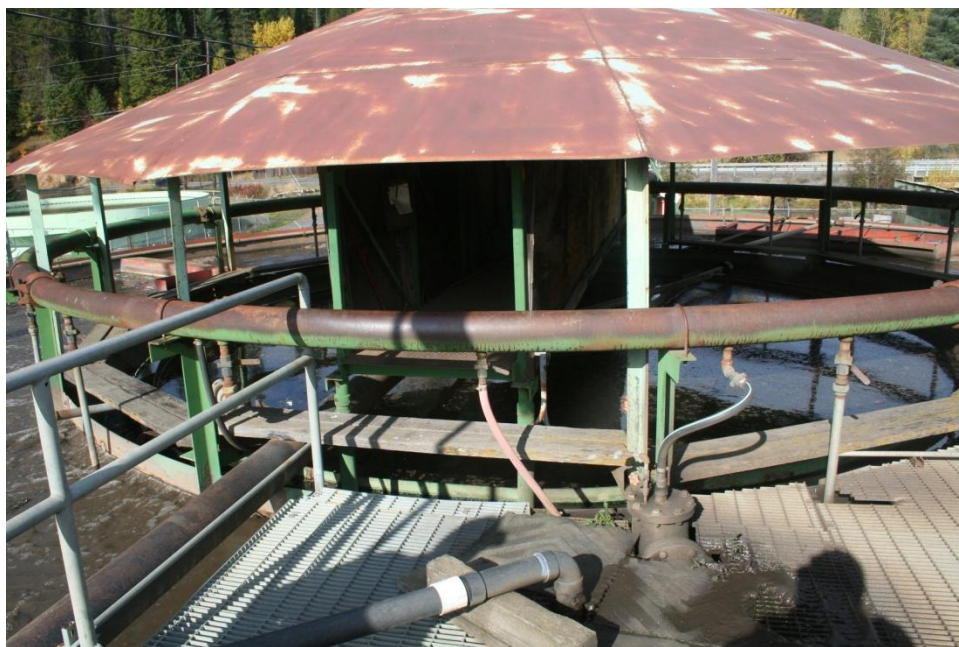
City of Pierce wastewater treatment plant package treatment plant. Photo by Jerry W. Shaffer (DEQ) on October 20, 2011.

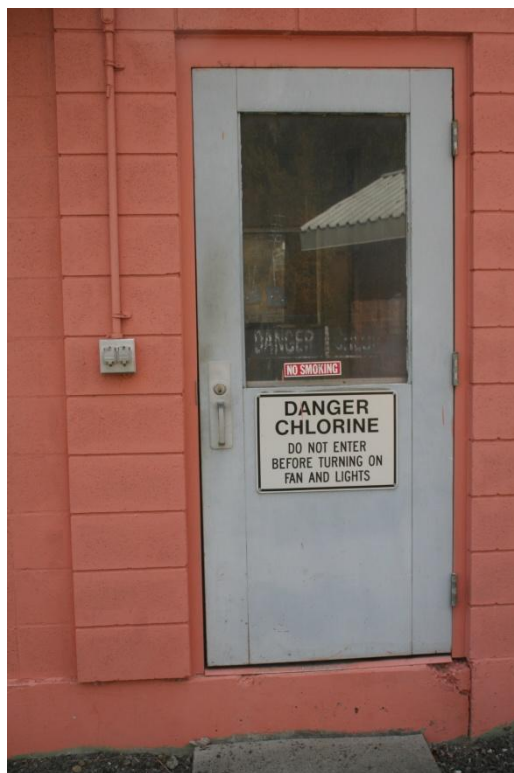
City of Pierce wastewater treatment plant gas chlorine room. Photo by Jerry W. Shaffer (DEQ) on October 20, 2011.

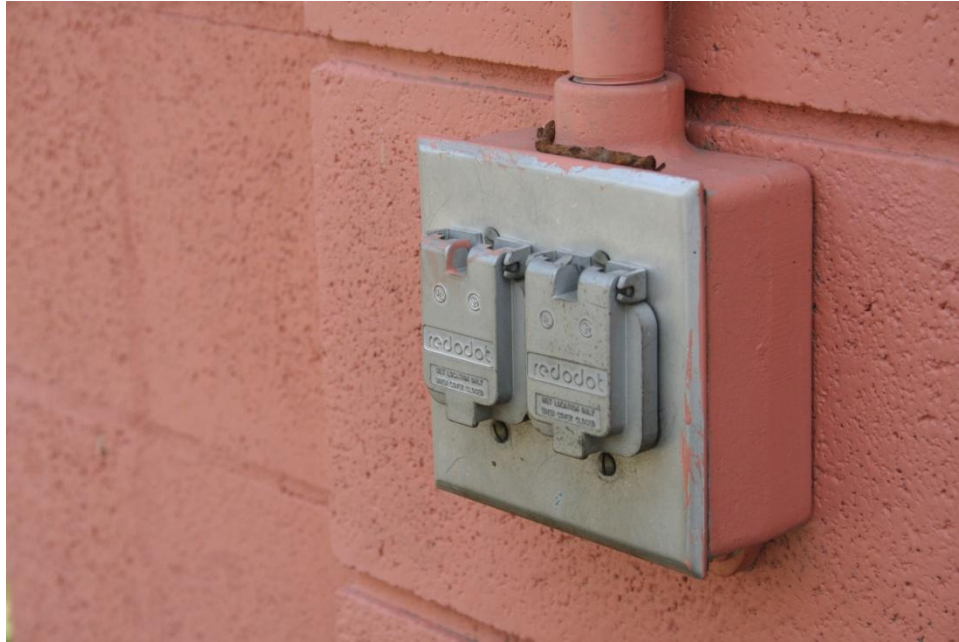
City of Pierce wastewater treatment plant gas chlorine room outside switches. Photo by Jerry W. Shaffer (DEQ) on October 20, 2011.

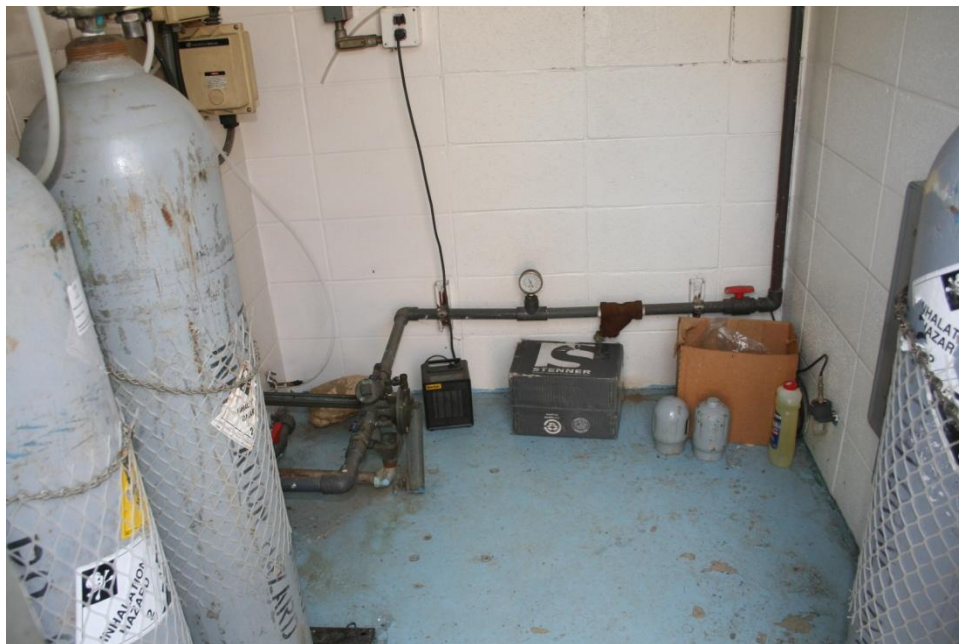
City of Pierce wastewater treatment plant gas chlorine room piping. Photo by Jerry W. Shaffer (DEQ) on October 20, 2011.

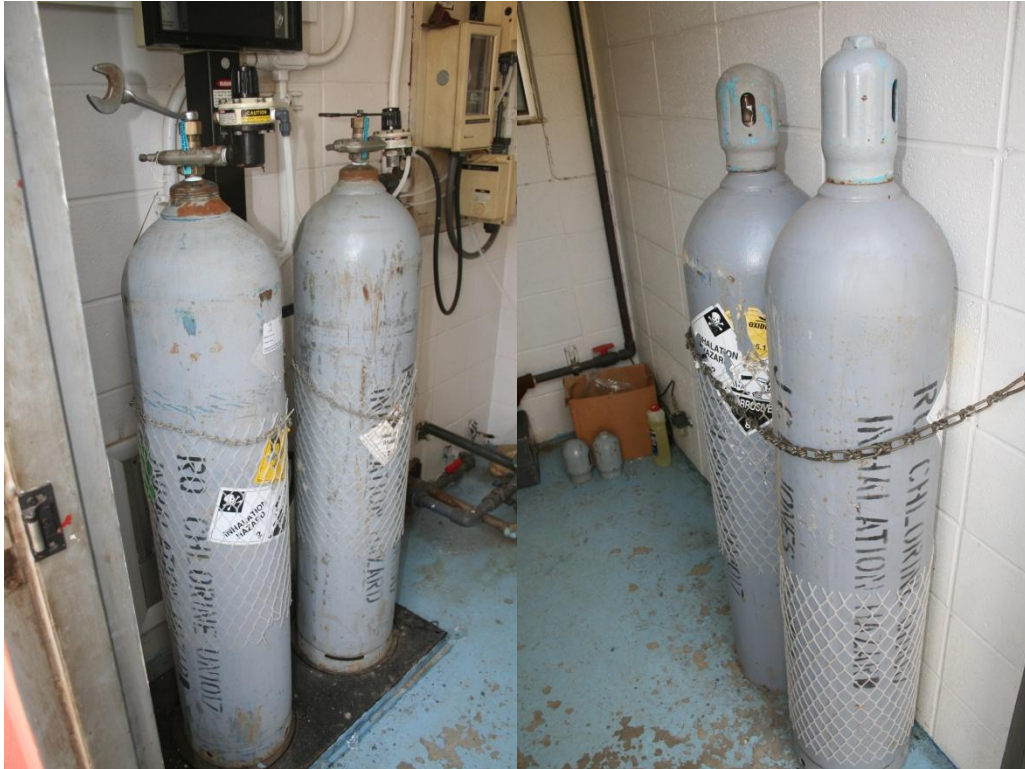
City of Pierce wastewater treatment plant gas chlorination room with chlorine cylinders. Photo by Jerry W. Shaffer (DEQ) on October 20, 2011.

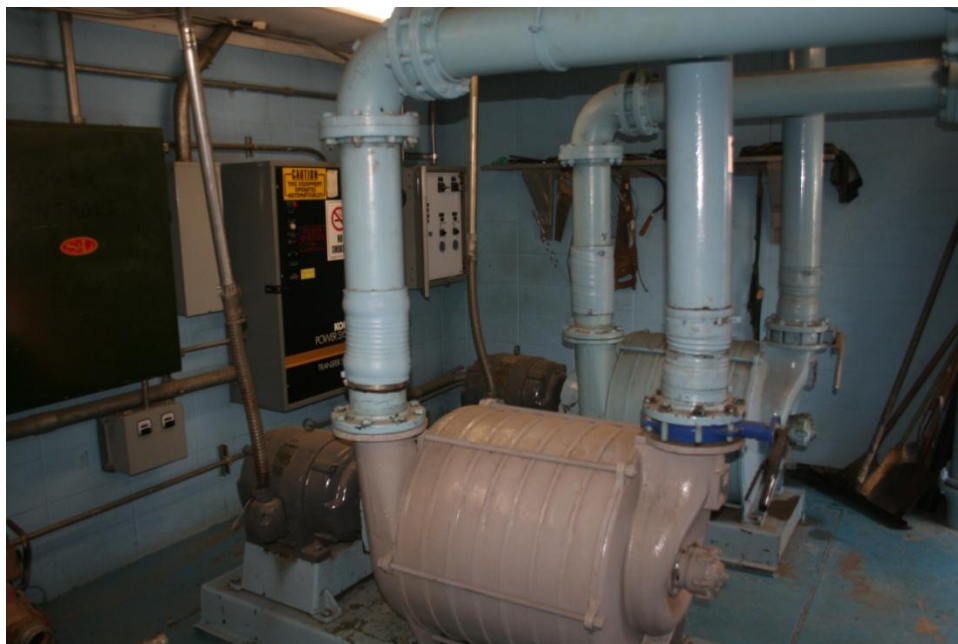
City of Pierce wastewater treatment plant blowers. Photo by Jerry W. Shaffer (DEQ) on October 20, 2011.

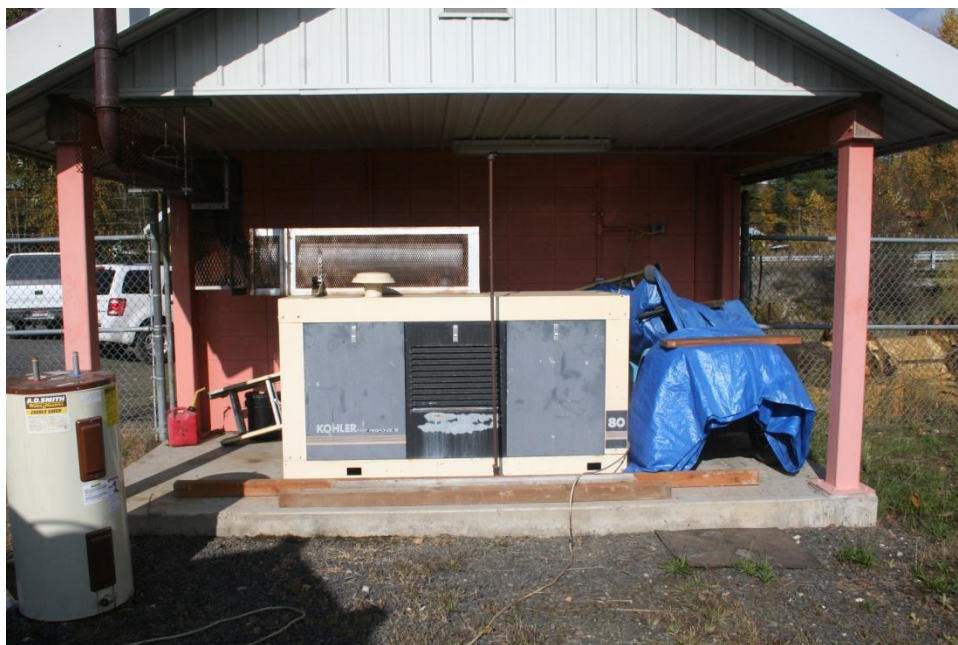
City of Pierce wastewater treatment plant auxiliary power. Photo by Jerry W. Shaffer (DEQ) on October 20, 2011.

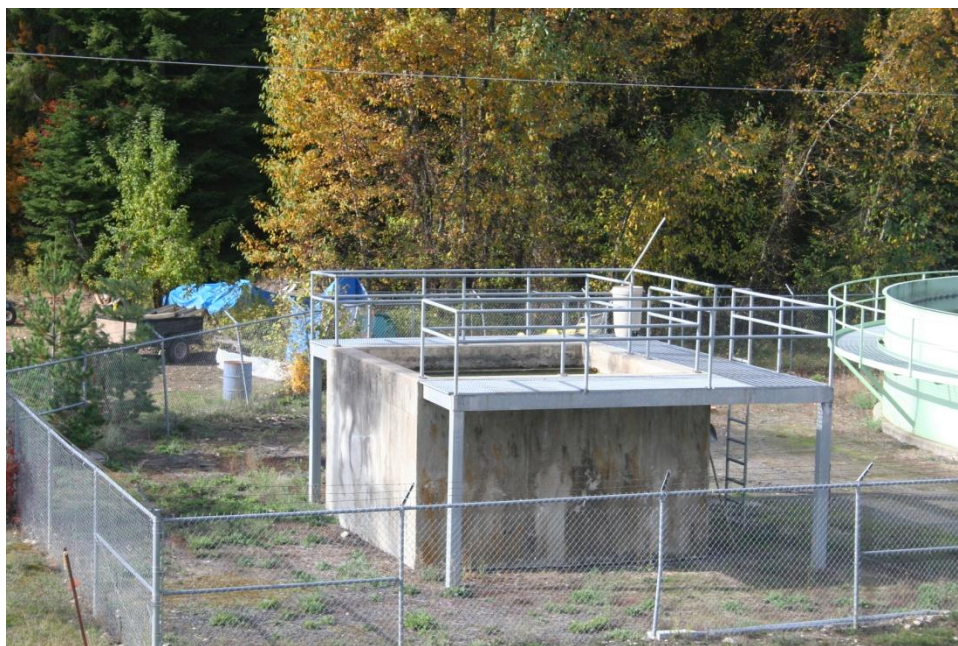
City of Pierce wastewater treatment plant chlorine contact basin. Photo by Jerry W. Shaffer (DEQ) on October 20, 2011.

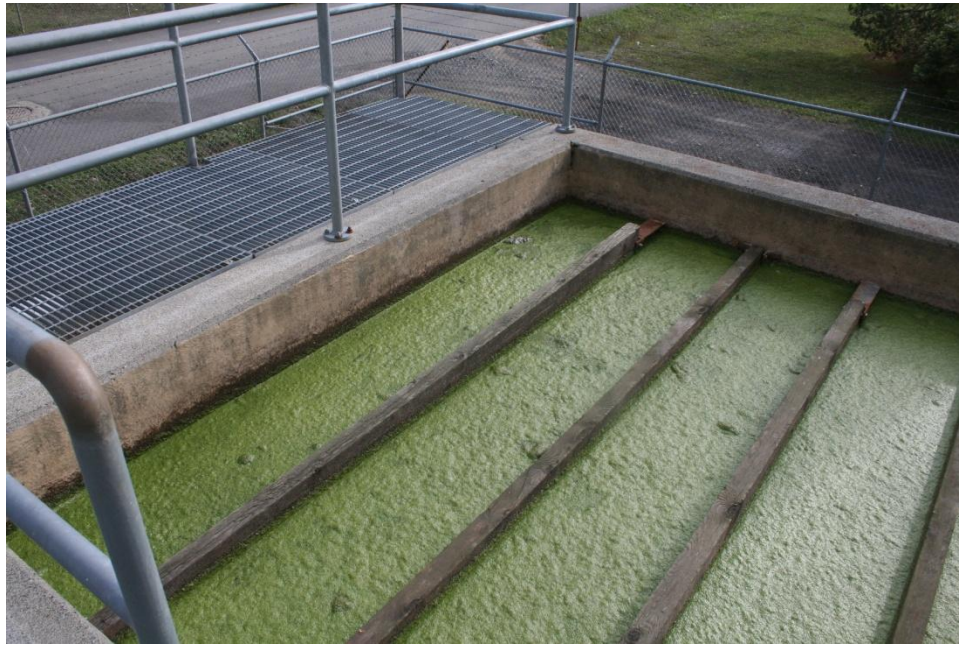
City of Pierce wastewater treatment plant chlorine contact basin. Photo by Jerry W. Shaffer (DEQ) on October 20, 2011.

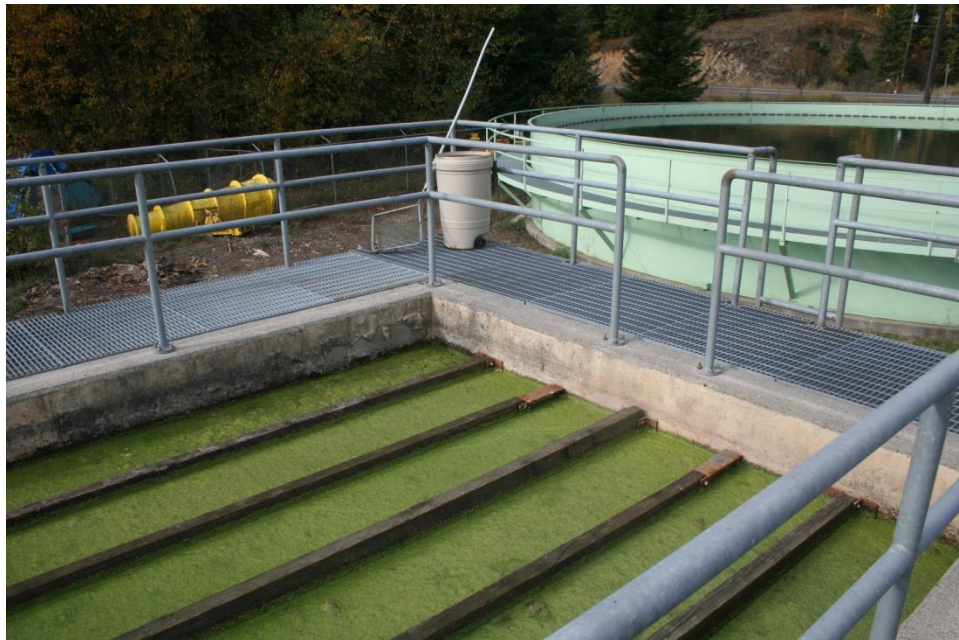
City of Pierce wastewater treatment plant chlorine contact basin with final settling basin in the background. Photo by Jerry W. Shaffer (DEQ) on October 20, 2011.

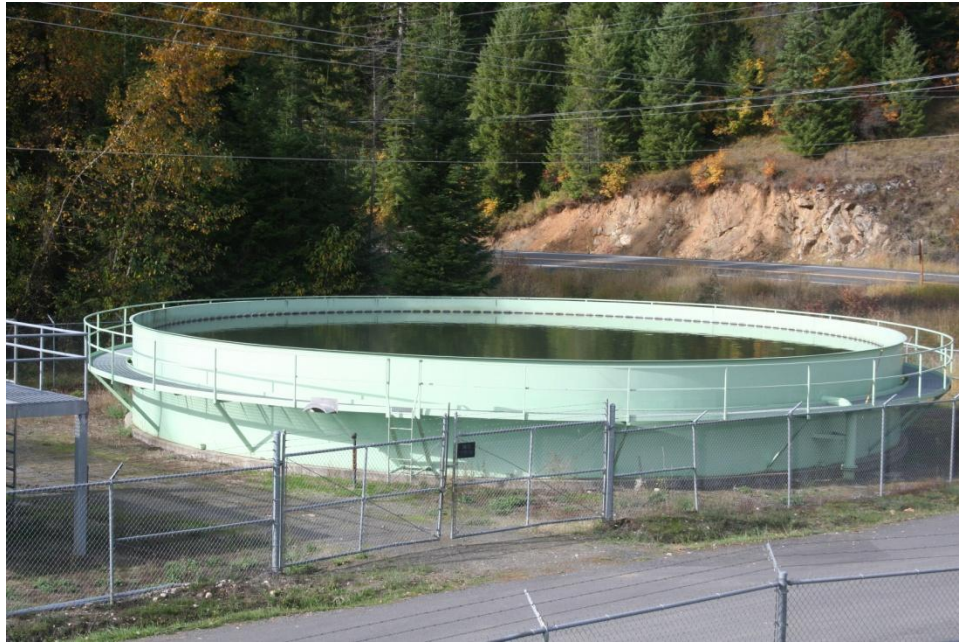
City of Pierce wastewater treatment plant final settling basin. Photo by Jerry W. Shaffer (DEQ) on October 20, 2011.

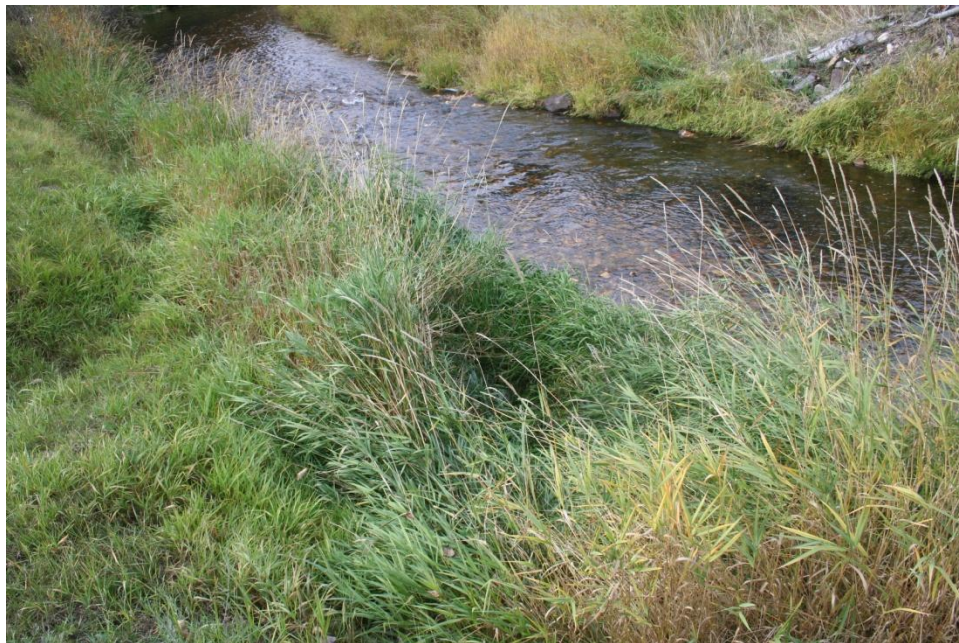
City of Pierce wastewater treatment plant discharge to Orofino Creek. Photo by Jerry W. Shaffer (DEQ) on October 20, 2011.

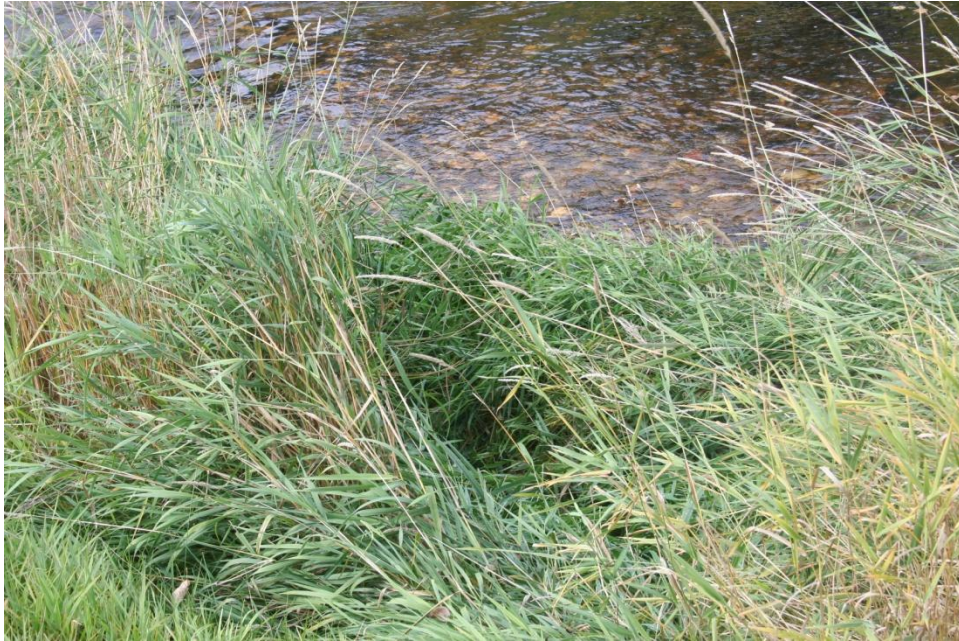
City of Pierce wastewater treatment plant discharge to Orofino Creek. Photo by Jerry W. Shaffer (DEQ) on October 20, 2011.
